PROJECT SCOPE OF WORK (ALL WORK IS EXTERIOR)

CONTRACT DOCUMENTS

100 YEAR EXTERIOR RENOVATION  
OF THE  
SEATTLE YACHT CLUB MAINSTATION  
1807 East Hamlin Street  
Seattle, Washington 98112

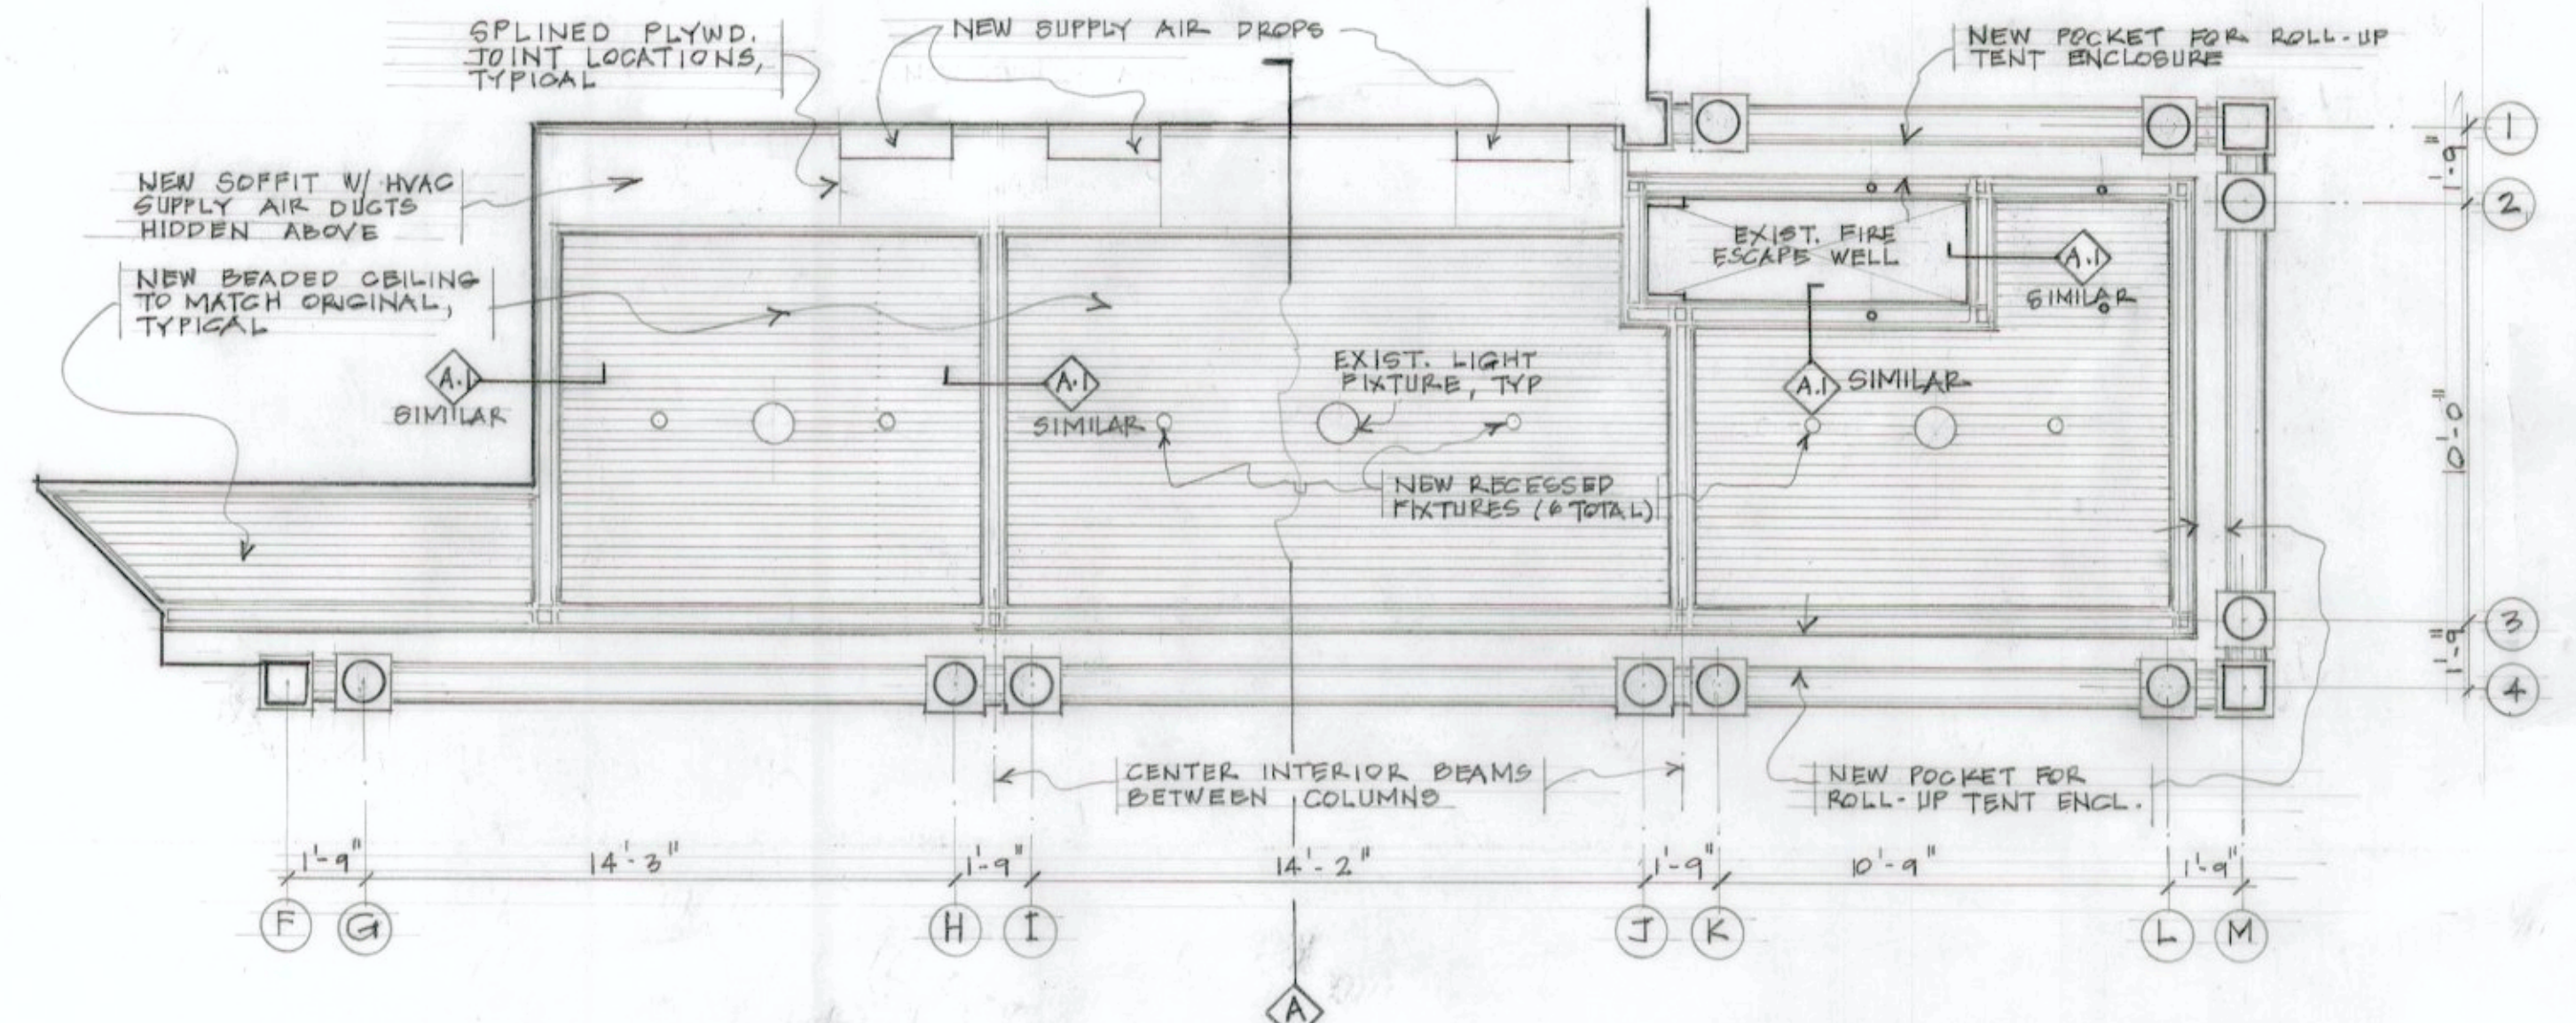
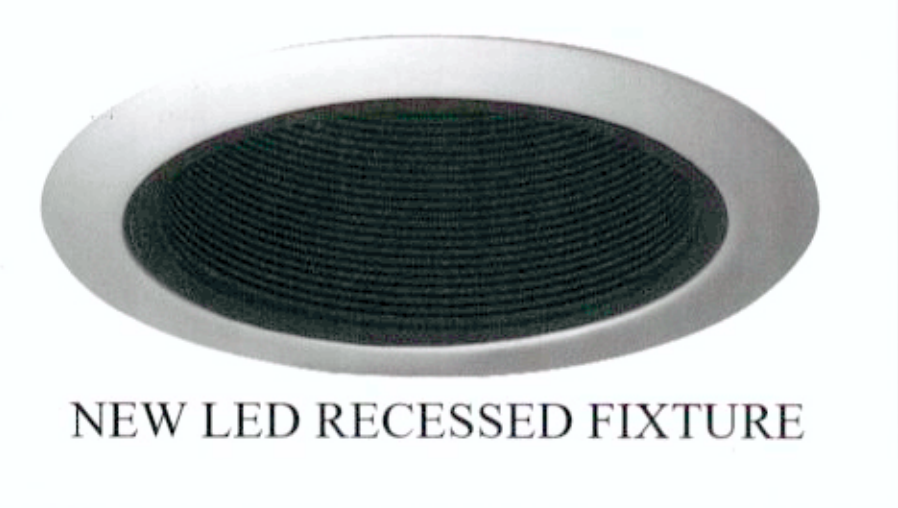
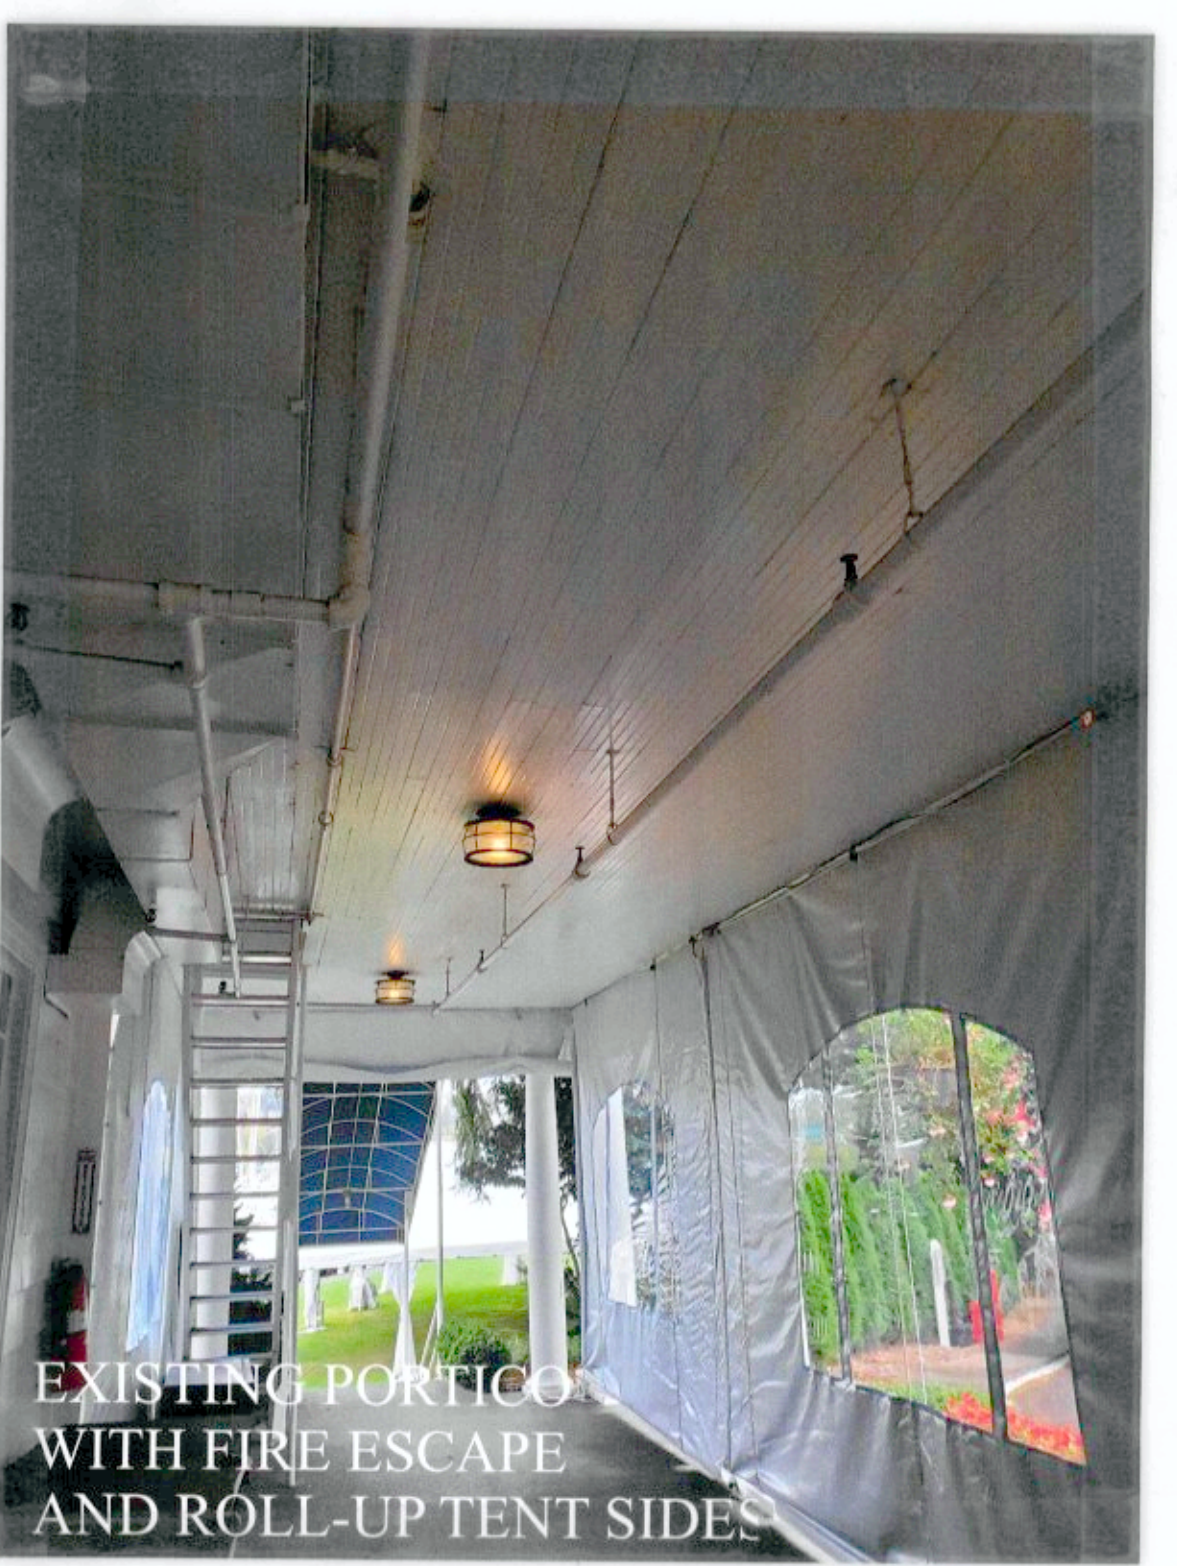
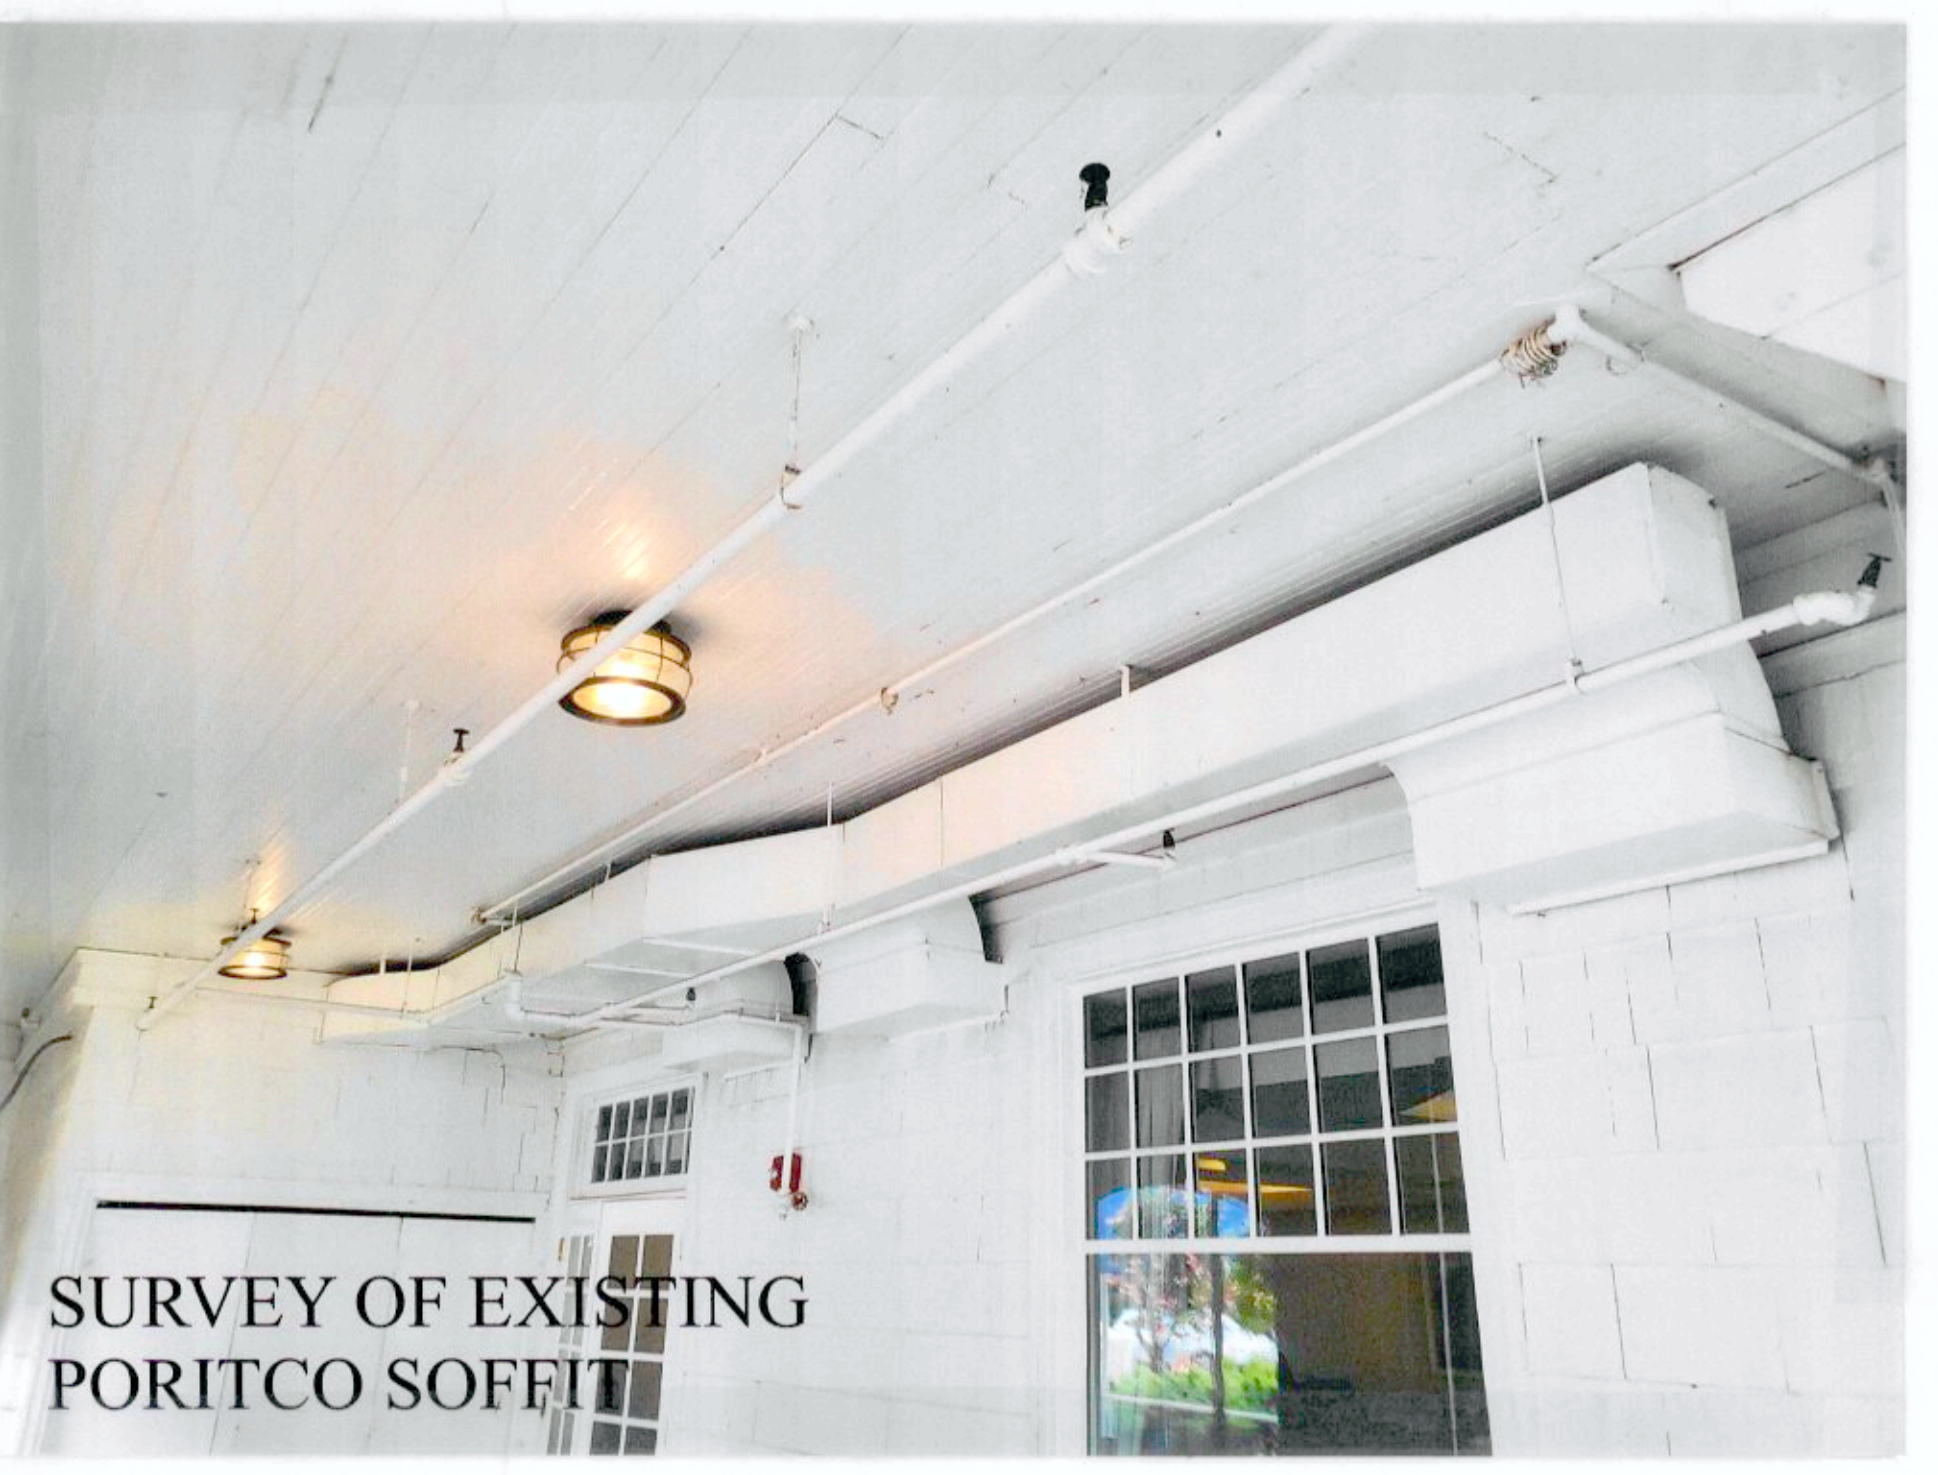
SHEET CONTENTS  
NORTH PORTICO  
CEILING DETAILS

FIXTURE SPECIFICATION:  
JUNO TC20 LED 5" x 4" HOUSING  
W/ 205 BWH TRIM AND  
11.5 W. LED LAMPS, 2700K.

C. NORTH PORTICO CEILING: (SEE SHEET 8)

1. REMOVE ALL EXISTING BEADED CEILING PANELING FROM THE SOFFIT OUTSIDE OF THE FIRESIDE LOUNGE.
2. REMOVE ALL HVAC DUCTWORK AND FIRE SUPPRESSION PIPING FROM THIS AREA.
3. INSTALL NEW BEADED CEILING BOARDS TO MATCH 1920 ORIGINAL.
4. INSTALL NEW CEILING TRIM TO MATCH 1920 ORIGINAL THAT CONCEALS THE EXPOSED DUCTWORK, PIPING, AND ROLL-UP TENT MATERIAL ADDED SINCE 1920.
5. RECONDITION THREE EXISTING CEILING LIGHT FIXTURES, AND ADD DISCREET RECESSED LED CEILING FIXTURES AS SHOWN FOR ADEQUATE LIGHTING.

- THE EXISTING SOFFIT AT THE NORTH PORTICO OUTSIDE OF THE FIRESIDE LOUNGE BECAUSE OF ITS UNSIGHTLY CONDITION, BADLY PLANNED AND EXECUTED MECANICAL, FIRE SUPPRESSION EQUIPMENT, FIRE ESCAPE STRUCTURE, AND ROLL-UP PERIMETER TENT WALLS, AND GENERAL DETERIORATION OF THE WOOD CEILING PANELING.

**THE BEADED SOFFIT BOARDS WILL BE REMOVED AND THE CEILING LEVELED TRUE, THE HVAC SHEETMETAL DUCTWORK RELOCATED, AND CONSOLODATED, THE FIRESUPPRESSION PIPING RELOCATED FOR BEST CONCEALMENT, NEW CEILING BEAMS THAT MATCH THE EXISTING PERMITER COLUMN BEAMS BUILT TO FORM A COFFERED CEILING PATTERN, AND A NEW SOFFIT THAT REPEATS THE CEILING BEAMS CONSTRUCTED CONCEAL THE RELOCATED DUCTS.** (SEE SHT. 8 FOR DETAILS AND SURVEY PHOTOS.)

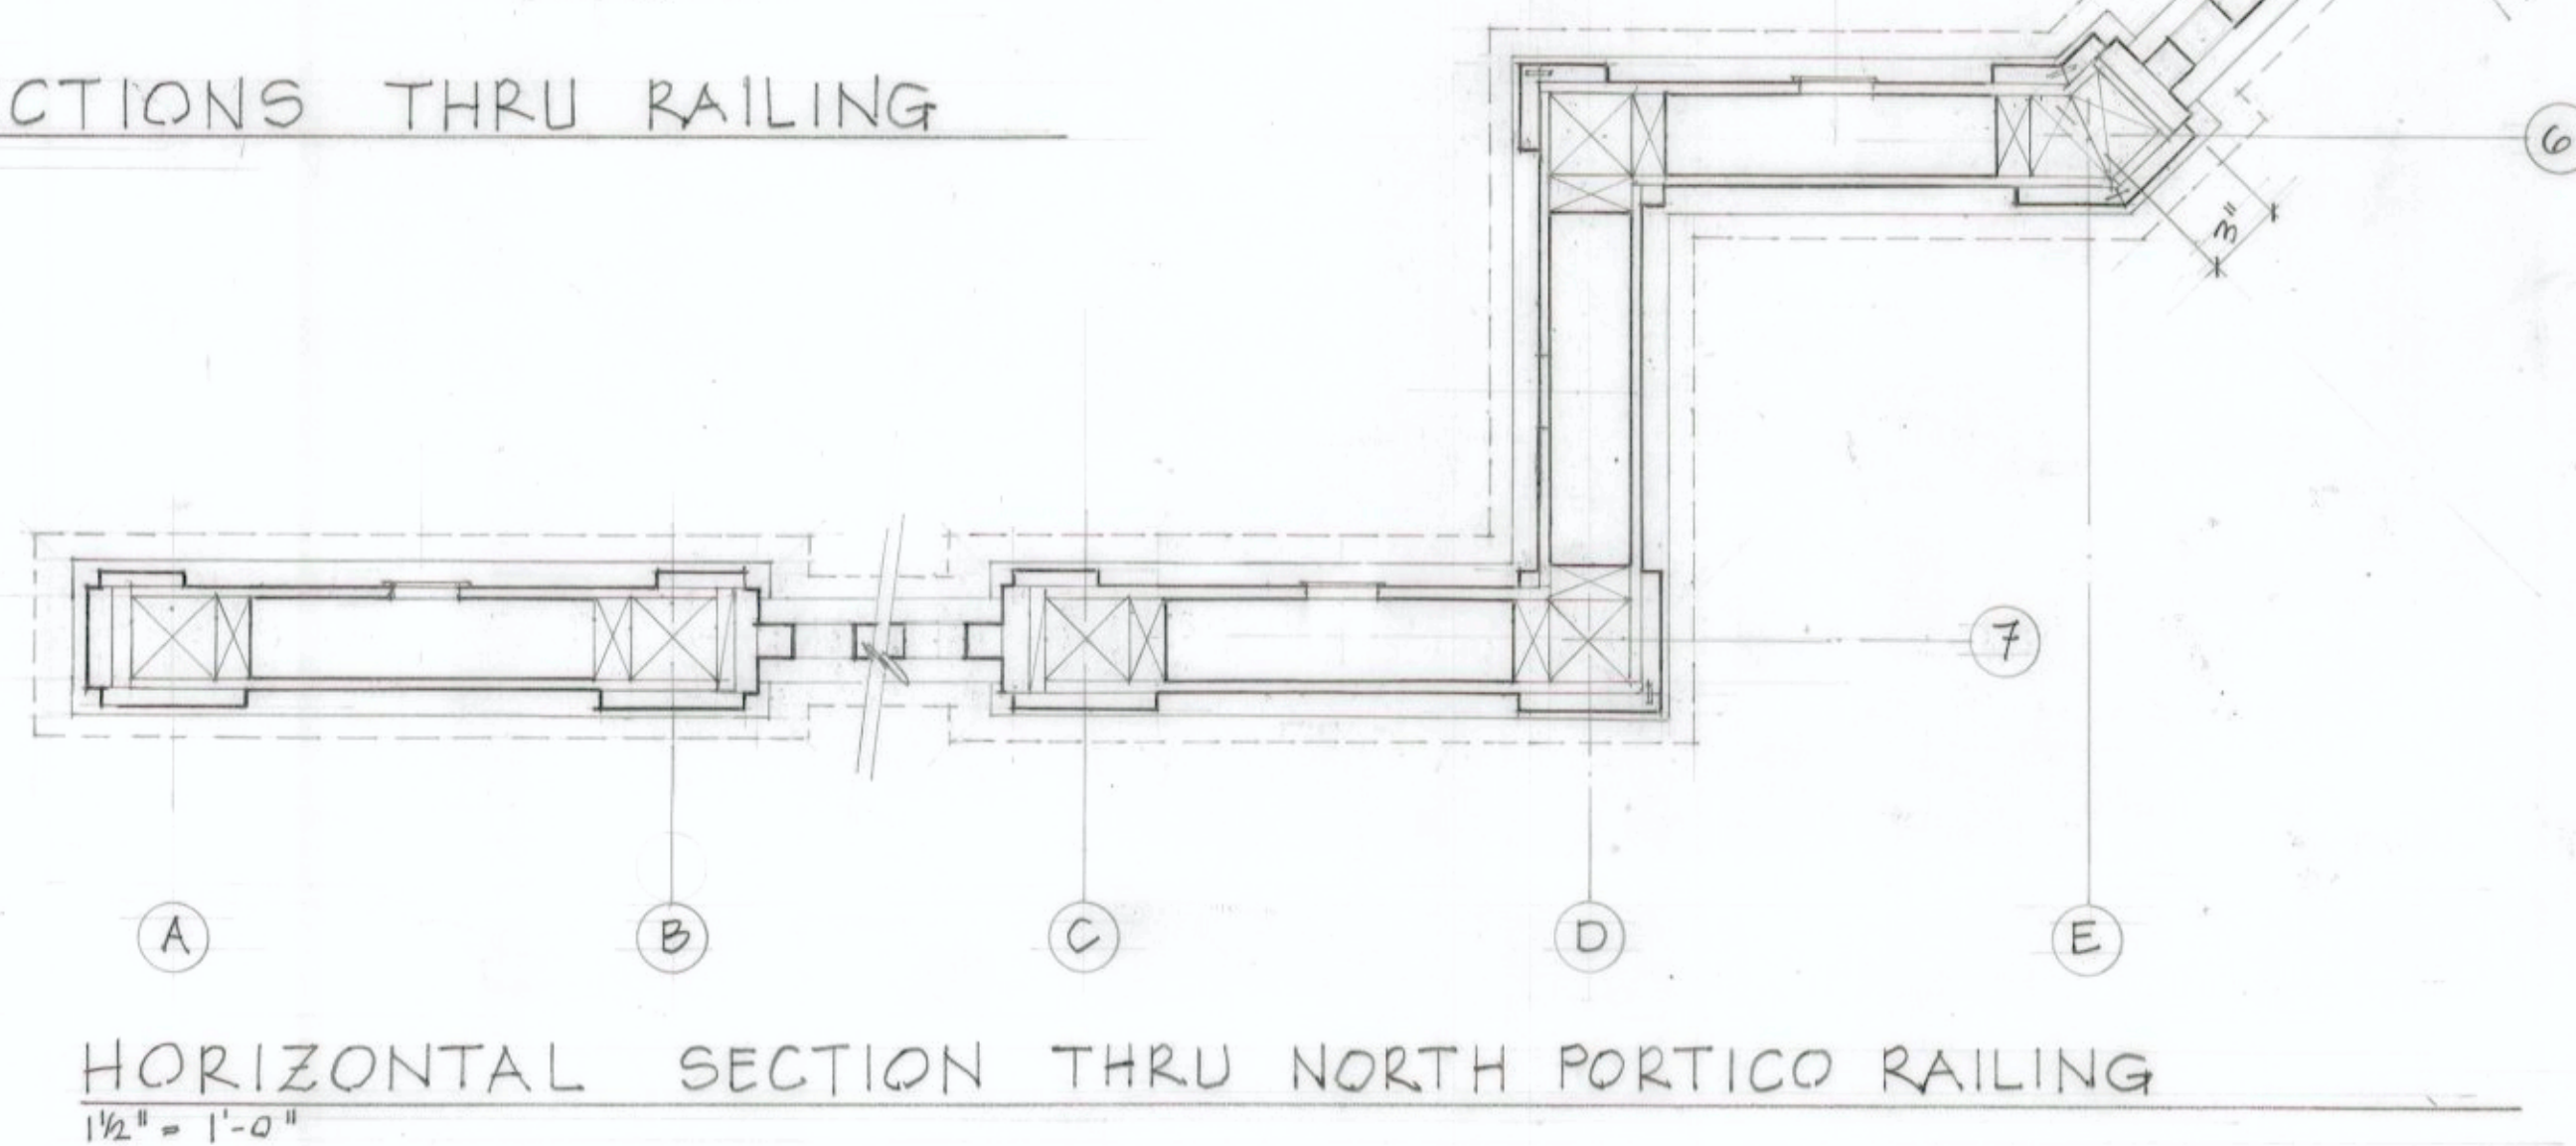
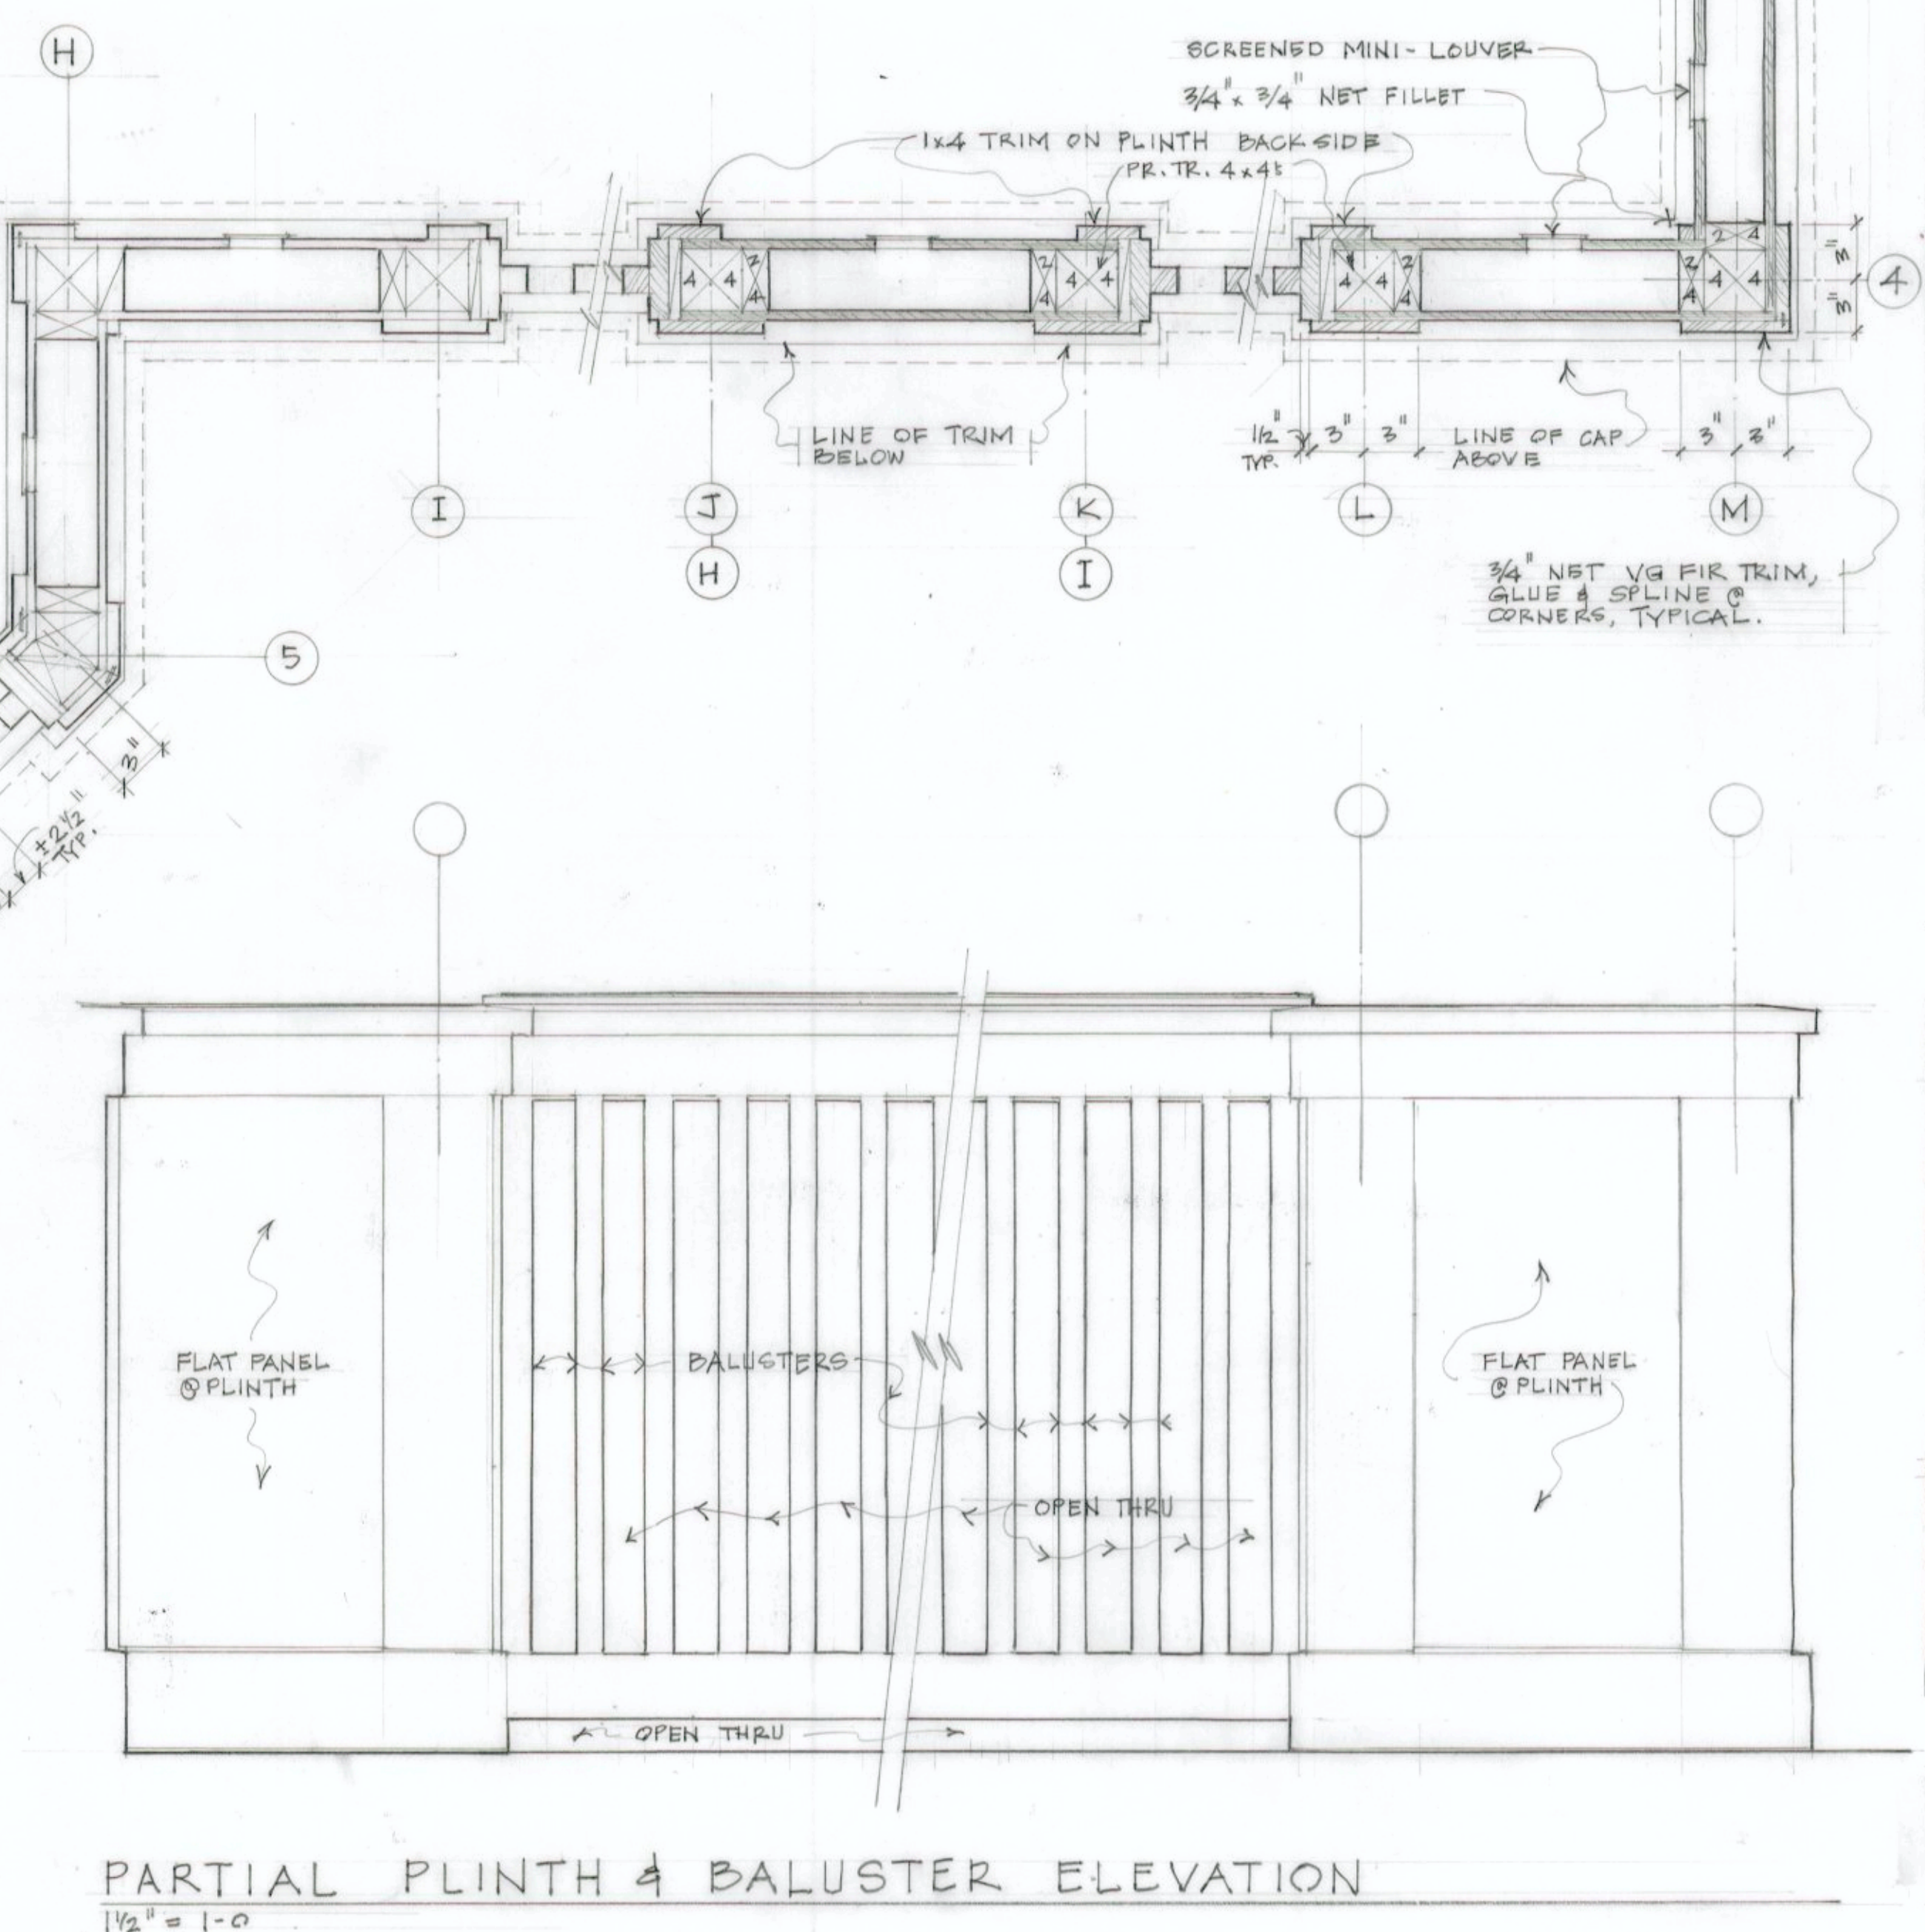
SHEET  
**9** OF

VERTICAL SECTIONS THRU RAILING

D. RAILING ABOVE NORTH PORTICO STRUCTURE: (SEE SHEET 9)

1. REMOVE ALL NON-CONFORMING, NON-ORIGINAL CIRCA 1963 RAILING AND REPLACE WITH NEW PLINTH AND BALUSTER STYLE RAILING THAT MATCHES THE 1920 ORIGINAL. PAINT ALL COMPONENTS KELLY MOORE "DIAMOND WHITE". SEE SHT 9.

- THE EXISTING RAILING ABOVE THE NORTH PORTICO STRUCTURE BECAUSE IT IS FAILING STRUCTURALLY AND IS A SAFETY HAZARD.

**THE OLD SECOND GENERATION RAILING (CIRCA 1963) WILL BE REPLACED WITH A CLASSIC BALUSTER & PILASTER STYLE RAILING THAT EXACTLY MATCHES THE ORIGINAL BUT CONFORMS TO CURRENT CODE STANDARDS.** (SEE SHT. 9 FOR DETAILS AND SURVEY PHOTOS)
